T700 ENGINE

PARTICLE SEPARATOR FRONT FRAME

COLD SPRAY REPAIR SERVICE

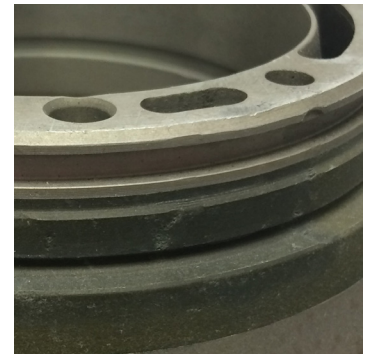
Corroded Part

Moog has developed and qualified a Cold Spray repair for the T700 engine Front Frame. The contact surface between the inlet guide vane spindle and the front frame housing is prone to corrosion and wear. Moog's repair allows the surface to be restored and re-machined to original specifications, thereby allowing a significant number of parts to be salvaged and returned to service. Moog has been approved by the US Army, Aviation and Missile Command (AMCOM) to offer and perform these services for all users of the T700 engine, which is being used on numerous aircraft across all U.S. service branches as well as in 50 countries.
