PRIZM™

Fiber Optic Modem Board (with Diagnostics)

Part Number 200530-xxx

User's Manual

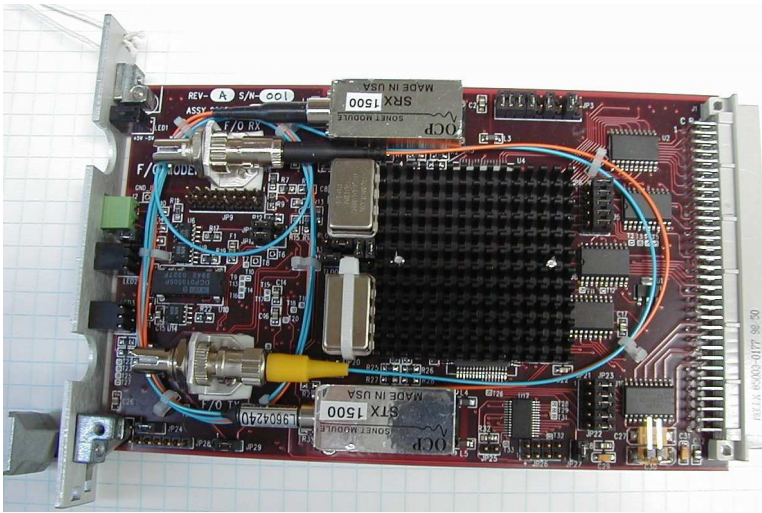
The Fiber Optic Modem board sends and receives digital data streams via fiber optic links from an opposing Fiber Optic Modem board. The Modem provides all of the timing and control functions, the high-speed link interface, data formatting for transmission, clock and clock recovery for reception, and parallel bus interface for the rest of the

system boards. The Modem board comes with fiber optic transmitter (a laser device) and receiver modules attached. 1.5Gbp optics is used in the standard configuration but other data rates are available.

The fiber optic transmitter and receiver modules have fiber optic pigtailed with optical connectors that are plugged into optical couplers mounted on the board and set back approximately 25mm (1 inch) from the front faceplate. The customer's field optical cables are plugged into these couplers. The couplers are typically ST single mode type but FC and SC are available optionally. The fiber pigtail on the transmitter laser module is 9 micron singlemode while the pigtail on the receiver is 50 micron multimode.

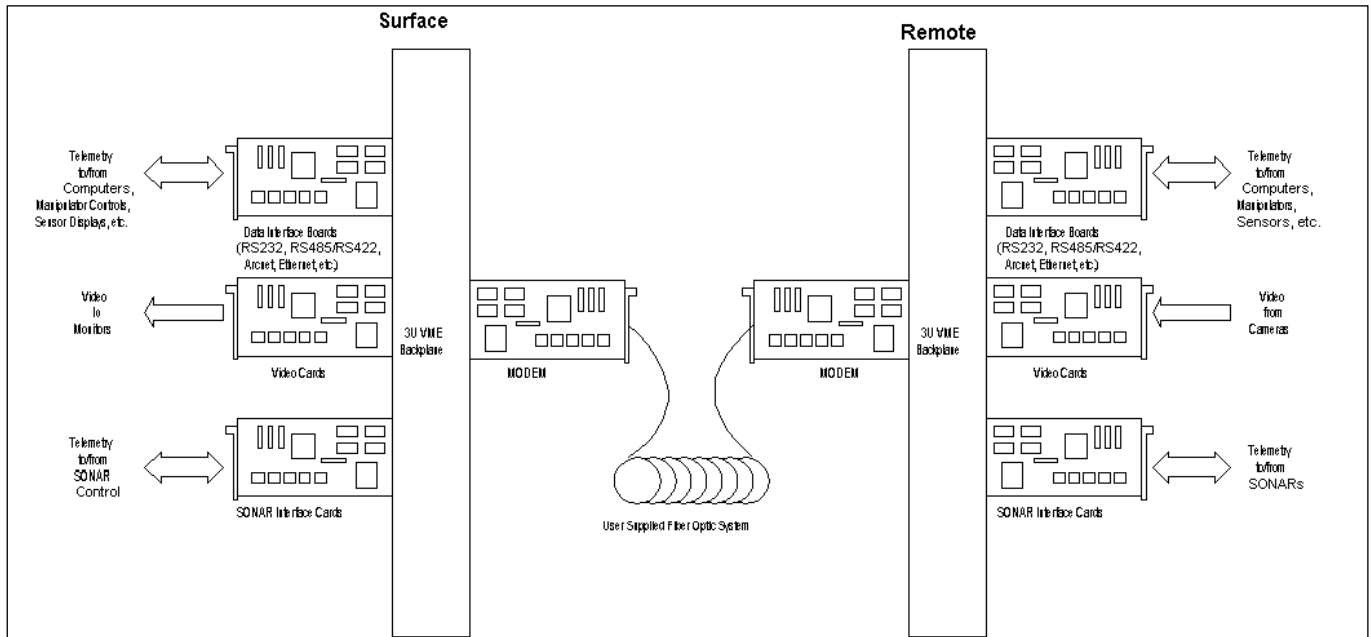
The Modem board interfaces to all the peripheral boards, as shown in the block diagram below.

The transmit path is defined as the data flow direction from the peripheral boards over the backplane to the Modem board for transmission over the serial link, to the remote system. The receive path is from the remote system, through the modem, onto the backplane, to the peripheral boards. When transmitting, the Modem board takes in all the various data and video signals from the Prizm system's peripheral boards and converts them to a single laser generated light signal, which is transmitted to the Prizm system at the other end of the fiber optic link. When receiving, the Modem board accepts the laser light signal from the other end of the fiber optic link converts it back to the original data and video signals and directs the reconstituted signals to the various peripheral boards in the Prizm system.

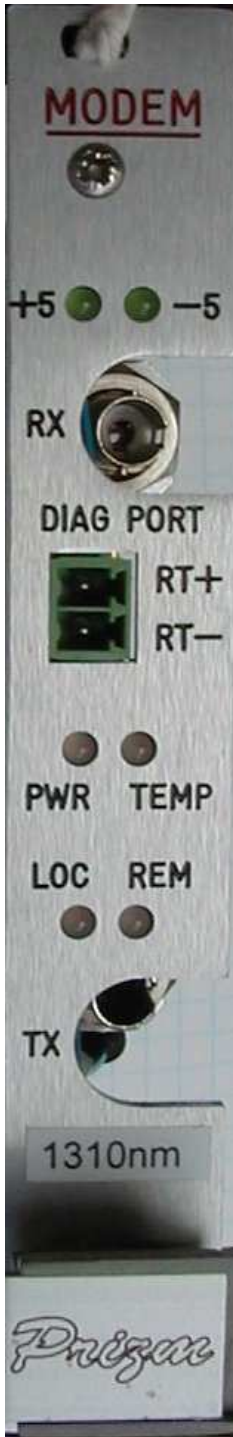
1.3.1 Modem Board Indicators and Connections:

There are six LED indicators on the front panel of the Modem board: +5, -5, PWR, TEMP, LOC, and REM.

The green +5 LED (p/o LED1) indicates the +5 VDC status of the board and is lit **GREEN** when +5VDC is available via the backplane.

The remaining LEDs are controlled via the on-board microcontroller that is part of the diagnostics capability. If the microcontroller fails the status of these may not be indicative of actual status. **NOTE: The diagnostics feature in no way interferes with normal operation of the modem – it is not necessary to be running the diagnostics s/w for the modem to work.**

The **LOC** LED (p/o LED3) is **GREEN** when the local receiver is receiving valid data and it is an indication that the received power is of acceptable level. This LED is **RED** when the local receiver is not receiving valid data and is an indication of either too low received power or receiver in saturation. The optical receiver has an operation range of approximately -6dBm (saturation) to -25dBm (sensitivity); signal levels that fall outside this range will result in invalid data and cause the LOC LED to turn RED.

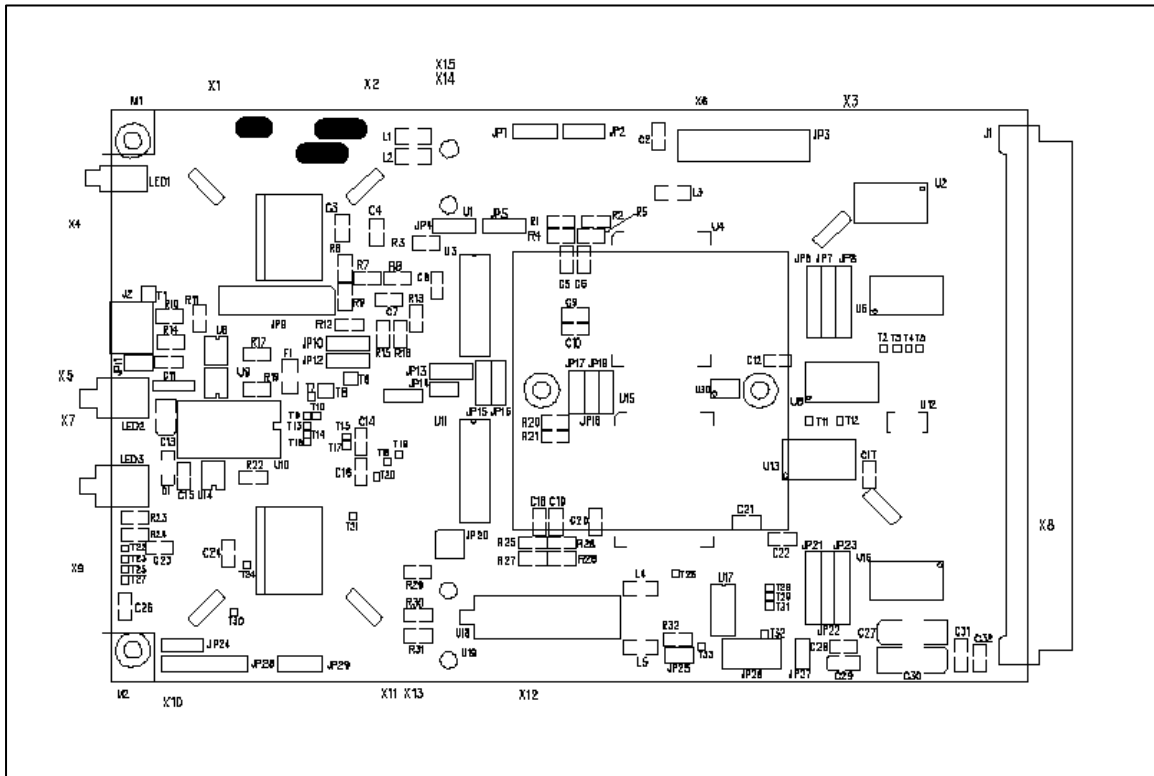
1.3.3 Modem Board Dimensions:

VME 3-U printed circuit board (PCB):

100 mm wide x 160 mm long x 15 mm high (3.937 in x 6.299 in x .6 in)

VME 3-U PCB and faceplate in rack: 15 mm wide x 128 mm high (.6 in x 5.05 in)
