FLUID POWER JOURNAL

MARCH/APRIL 2016

A Planned Outage

SPURS A UNIQUE APPROACH FOR TURBINE MAINTENANCE By Steven Beddick, Moog Inc.

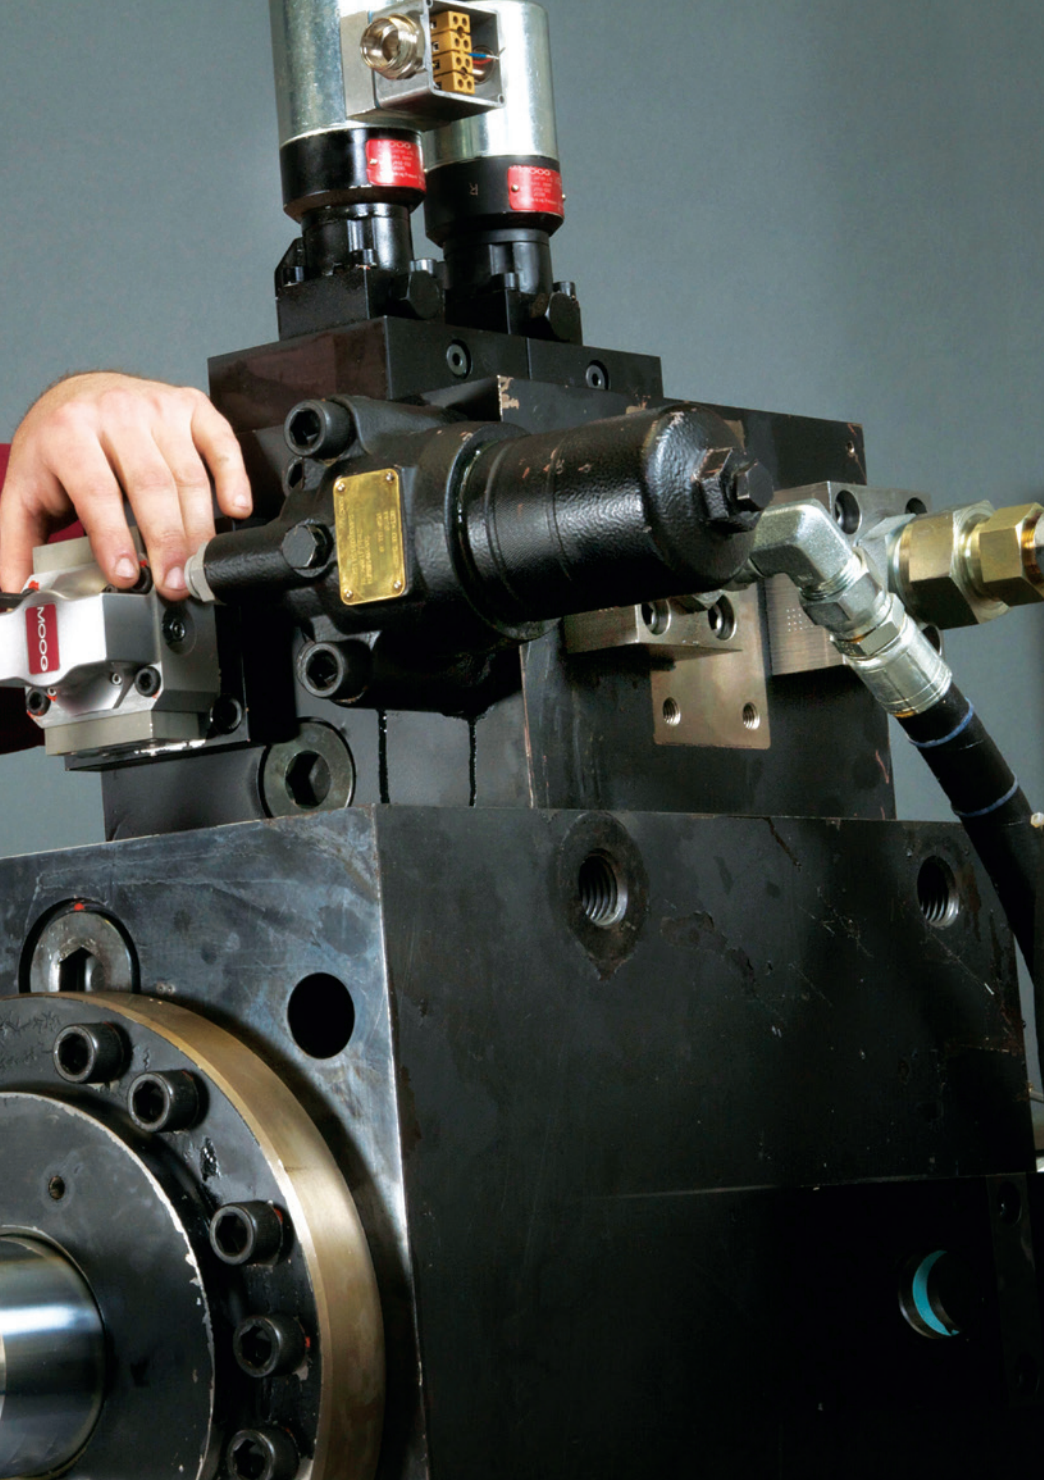
← A service technician at Moog's turbine actuator overhaul facility reconnects a reconditioned hydraulic servo valve to an actuator as part of the refurbishing process.
