# A Planned Outage Spurs a Unique Approach for

# TURBINE

# MAINTENANCE

When power plant managers realized their scheduled window for a steam valve outage was challenging, engineers came up with a new tactic for servicing a dozen actuators and steam valves in less than 12 days.

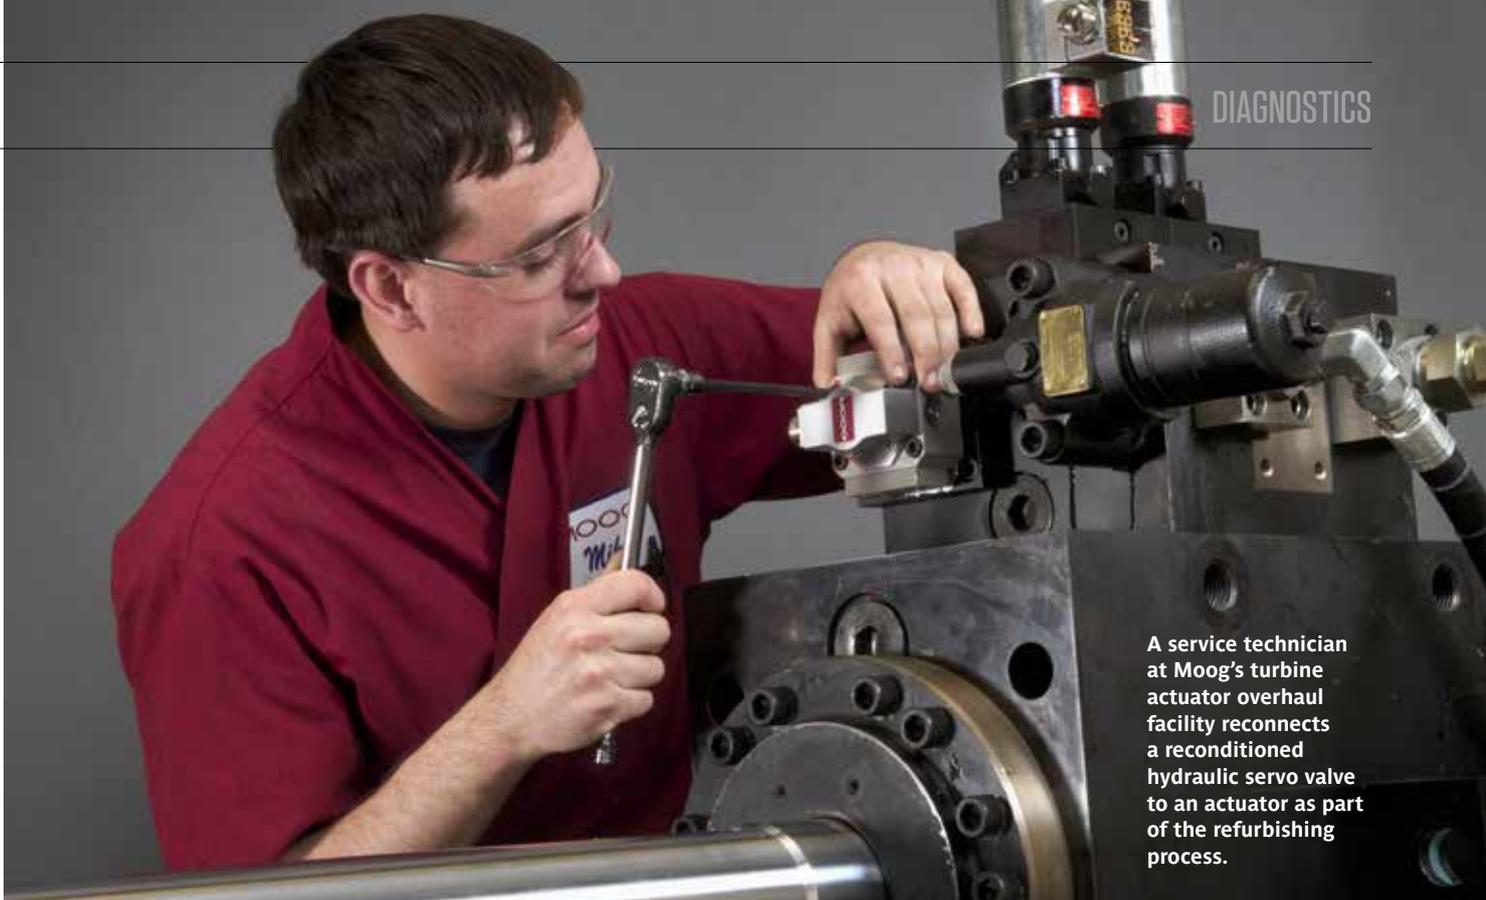
A service technician at Moog's turbine actuator overhaul facility reconnects a reconditioned hydraulic servo valve to an actuator as part of the refurbishing process.

The field crew sent the four control valves to the factory for overhaul. To meet the outage window, two shifts were deployed. These units went through the manufacturer's exacting overhaul programme and, when completed, each was tested to the same specifications and used the same procedures as when the new Toshiba turbine was delivered several years earlier. The factory overhaul process replaces bearings and replaces or refurbishes rods, where a field refurbishment is limited to seals and soft goods.

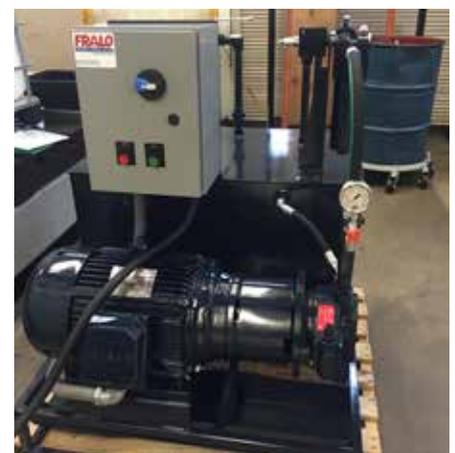
Moog-designed portable hydraulic test cart ready for shipping from the factory.

neers needed hydraulic power. However, it was determined that when the turbine was shutdown, there was no hydraulic power to draw from. To overcome this, Moog designed and built a portable hydraulic test cart with an integral hydraulic power unit (HPU).

Once the servo valves were reinstalled on the actuator, the crew used the test cart to confirm the safety failsafe functionality and internal leakage rate (to ensure the seals were working). The technicians ran the actuator through
